HIGH TEMPERATURE COMPATABILITY OF  $UO_2$   
WITH W-25 Wt % Re

R. A. Ekvall and J. O. Hegland

CONTRACT NAS3-2544

NUCLEAR THERMIONIC POWER OPERATION  
NUCLEAR TECHNOLOGY DEPARTMENT

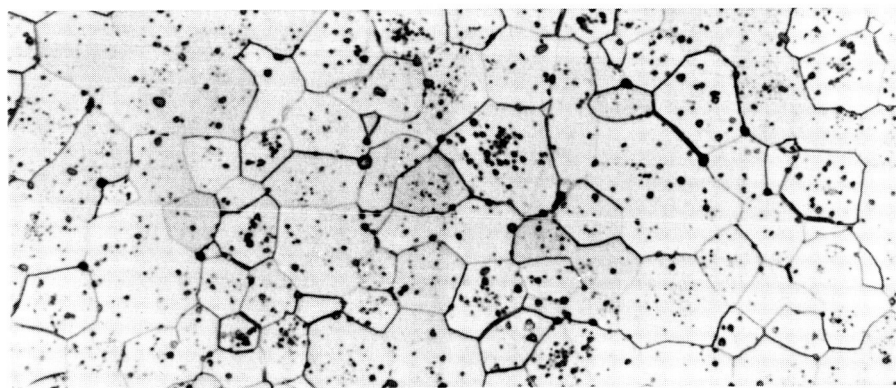
Figure 2. Photomicrograph of UO<sub>2</sub> Pellet

Etched

500X

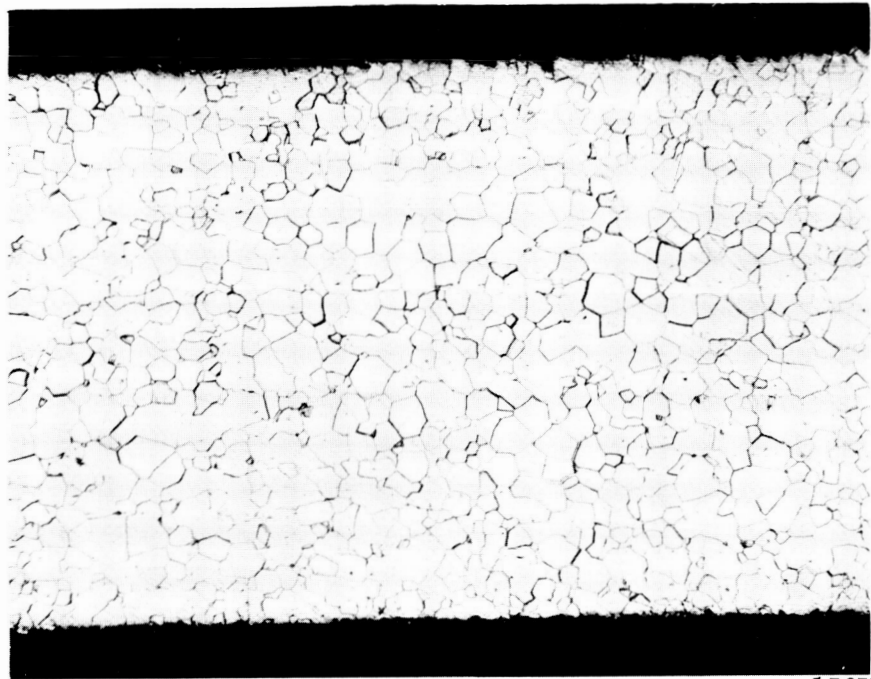
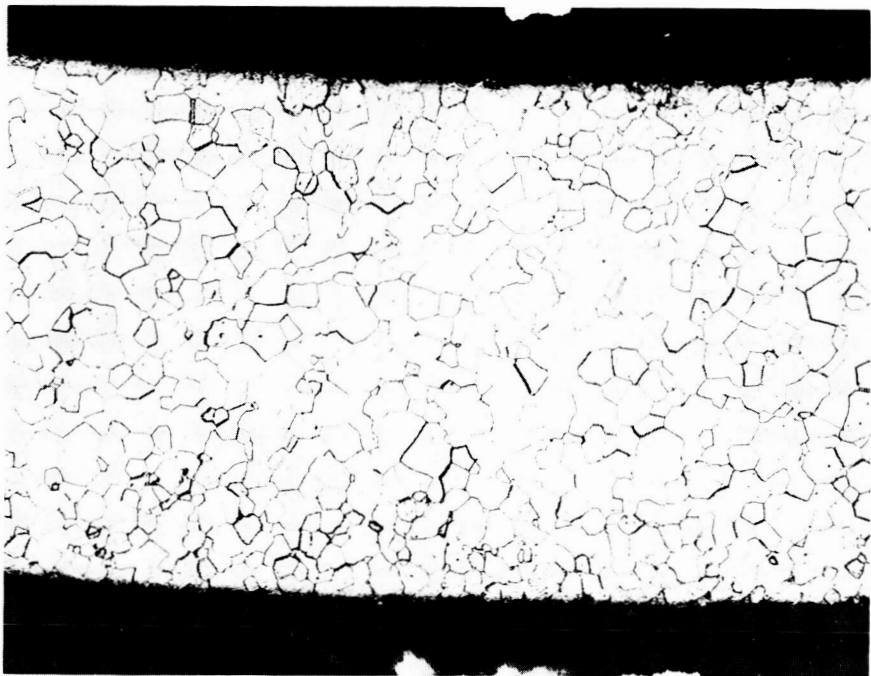
FIGURE 4. W-25 Wt % Re TUBE FROM CHASE BRASS

a. Longitudinal Section

b. Transverse Section

examined metallographically. No sigma phase was detected at 500X. Microstructures of the longitudinal and transverse sections are illustrated in Figure 4. A typical microstructure of the Hoskins W-25 wt % Re rod is shown in Figure 5. Chemical and spectrographic analyses of the material were made, and the data obtained are given in Table II. Both the rod and tube material were inspected with fluorescent penetrant (Zyglo); the tube material also was leak checked with a helium mass spectrometer leak detector.

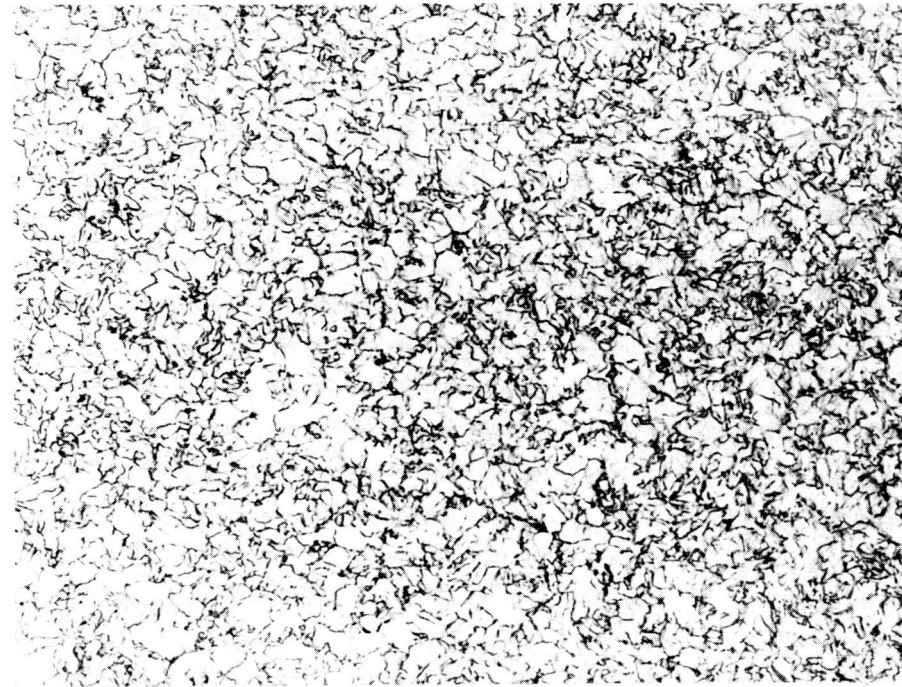
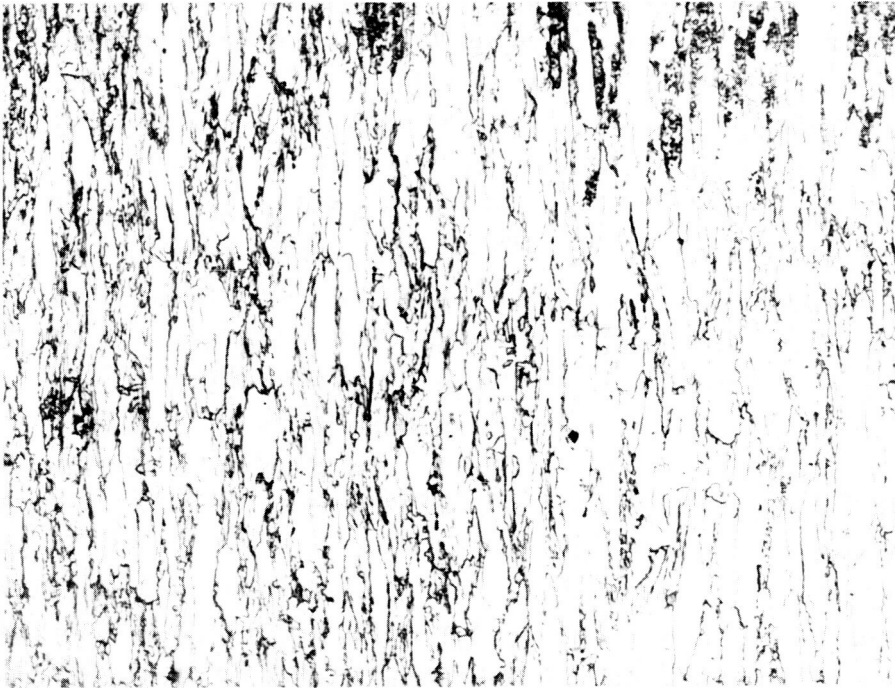
FIGURE 5. TYPICAL AS-RECEIVED W-25% RE ROD FROM HOSKINS

b. Transverse Section

a. Longitudinal Section

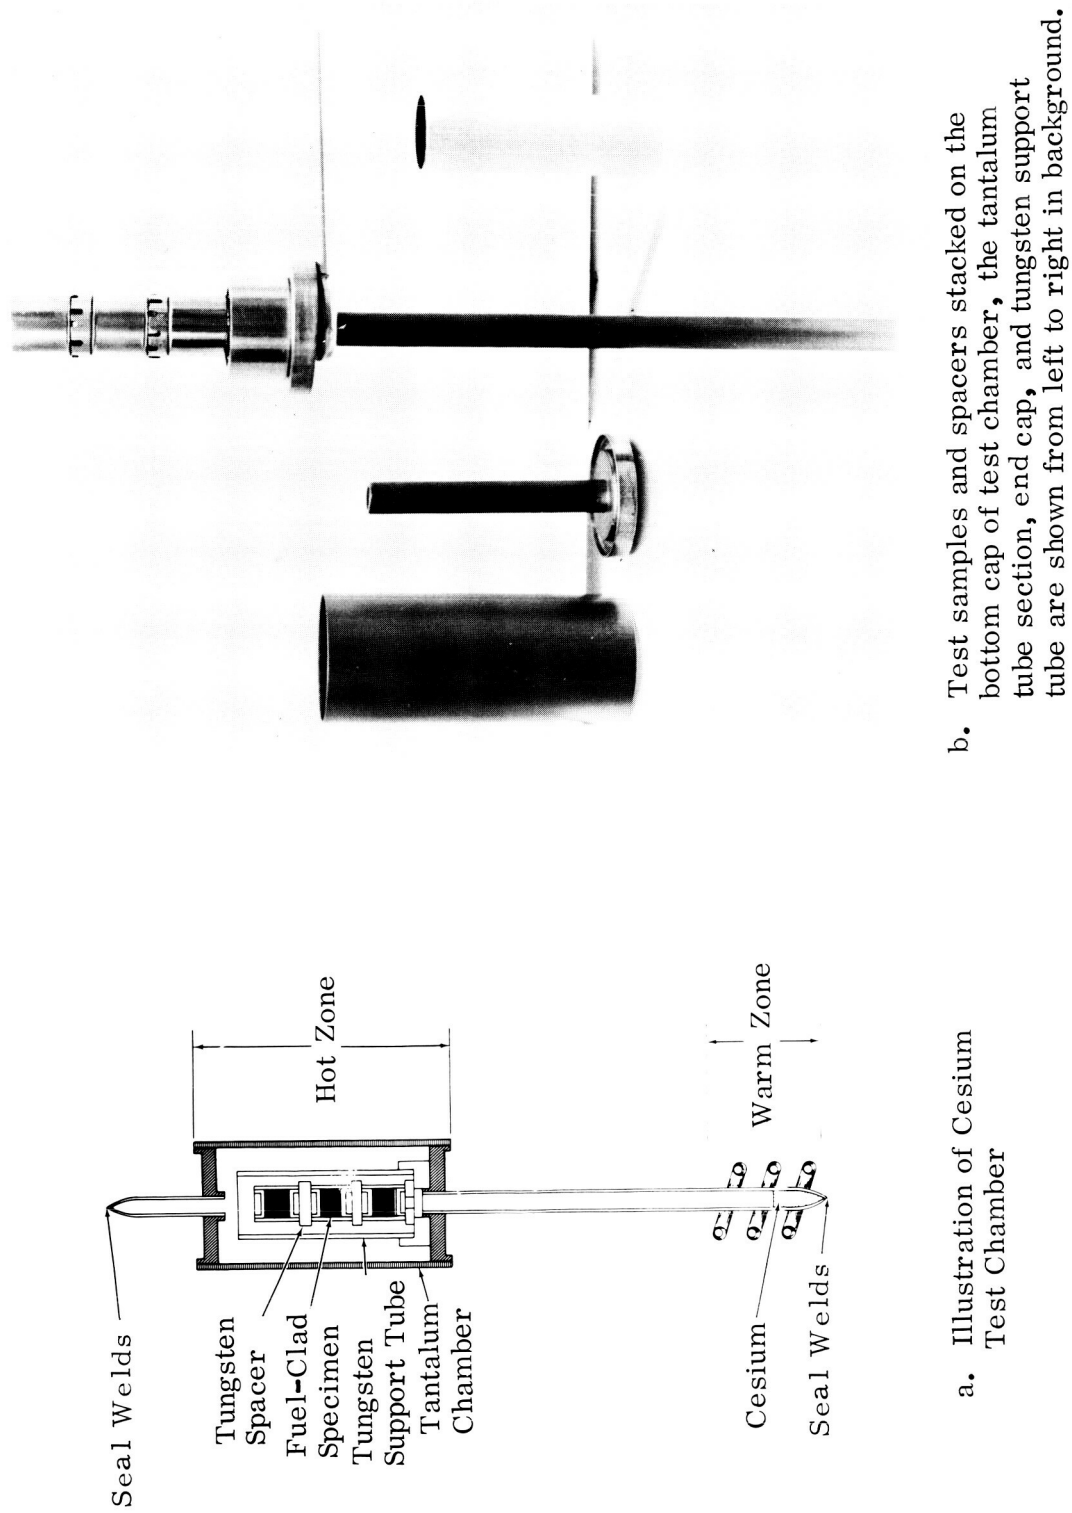
a. Illustration of Cesium Test Chamber

b. Test samples and spacers stacked on the bottom cap of test chamber, the tantalum tube section, end cap, and tungsten support tube are shown from left to right in background.

Cesium Environmental Chamber - The test chamber contained the cesium atmosphere to which the capsules were exposed during isothermal testing in the furnace. Figure 8 shows the completed test chamber which was fabricated entirely from tantalum by TIG welding end caps to a tube section to form a chamber approximately 3 inches long, and 1 inch in diameter, with a wall thickness of 0.020 inch. A 1/4-inch diameter tube was welded to each end cap over a hole in the center of the cap. The tube connected to the bottom end cap was seal welded before assembly. The tube attached to the top cap was left unsealed until the remainder of the test components were assembled in an argon atmosphere.

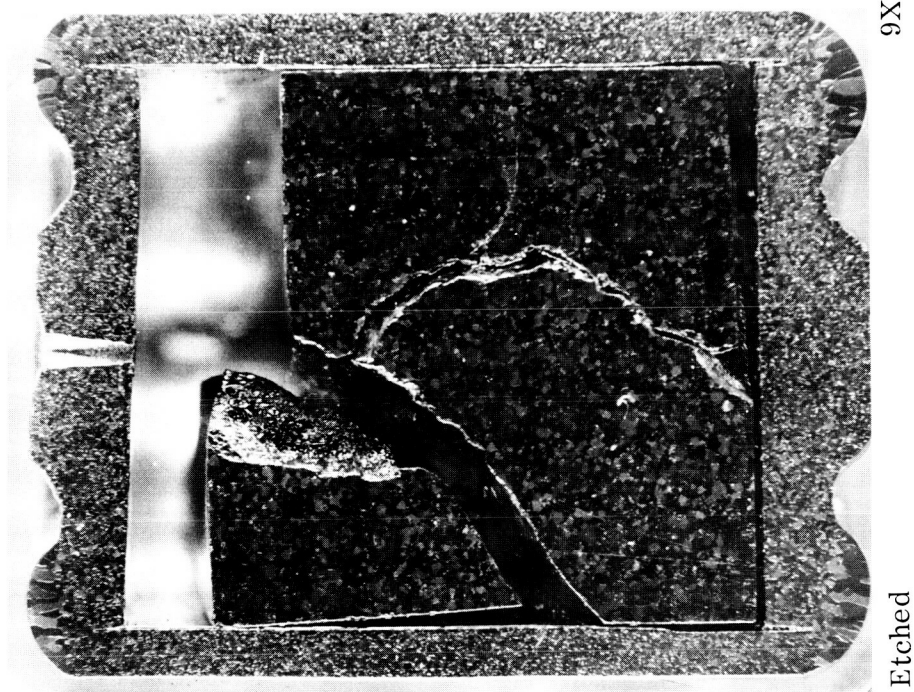
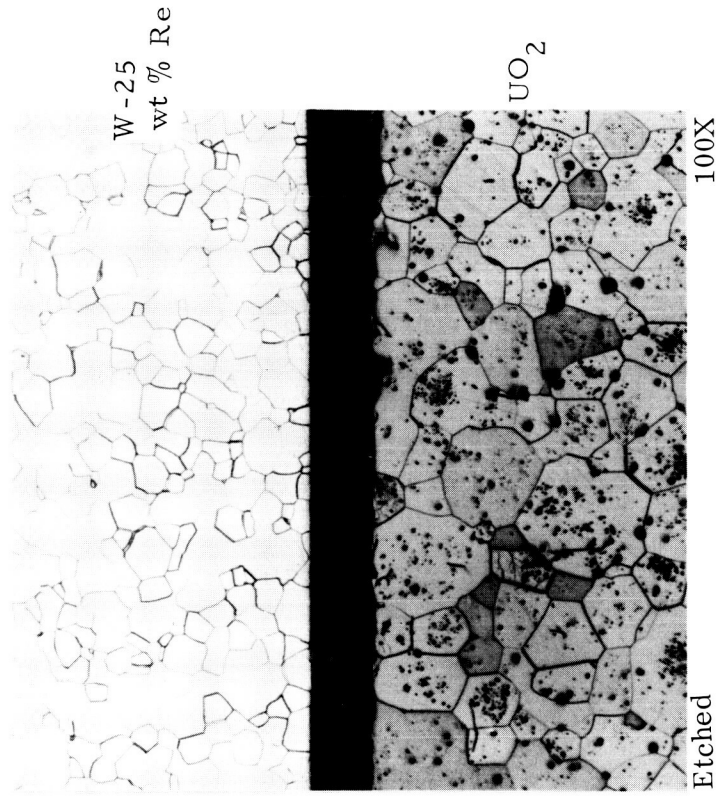
FIGURE 9. CAPSULE NO. 2 1800°C - 2000 hours

a. Macrograph of longitudinal Section

b. Typical Interface Between  
W-25 wt % Re and UO<sub>2</sub>  
Longitudinal Section of  
Container Wall

Capsule 2 was sectioned and examined metallographically. A macrograph of the longitudinal section is illustrated in Figure 9a. The fractures in the  $\text{UO}_2$  pellet were probably caused by the sectioning operation. Observations of the W-25 wt % Re- $\text{UO}_2$  interface revealed no evidence of interaction. A typical interface is shown in Figure 9b. The separation between the  $\text{UO}_2$  and cladding was designed in the capsule to allow for the  $\text{UO}_2$  expansion ( $\text{UO}_2$  expansion > W-25 wt % Re) in heating the capsule to the test temperature. No evidence of sigma phase was detected in the cladding material. Grain size and hardness measurements were made on the W-25 wt % Re cladding and were essentially unchanged.

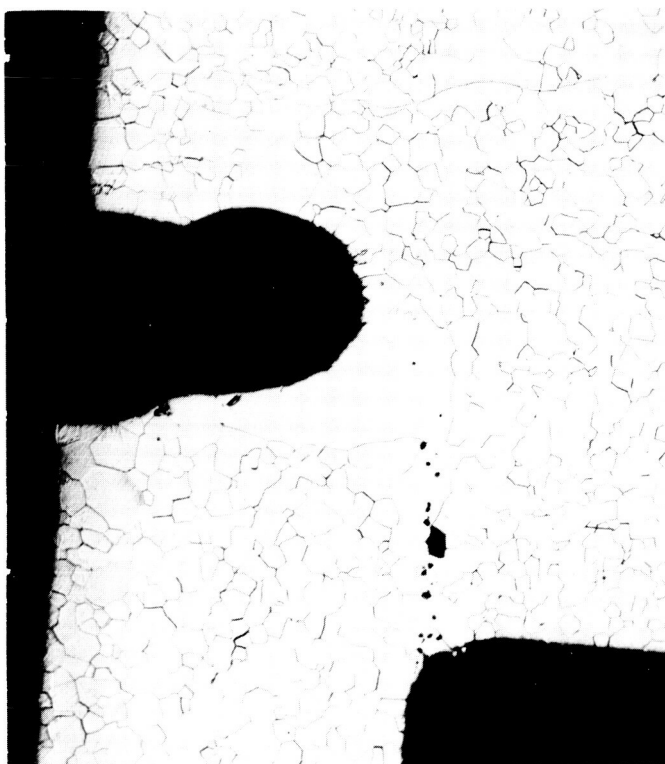
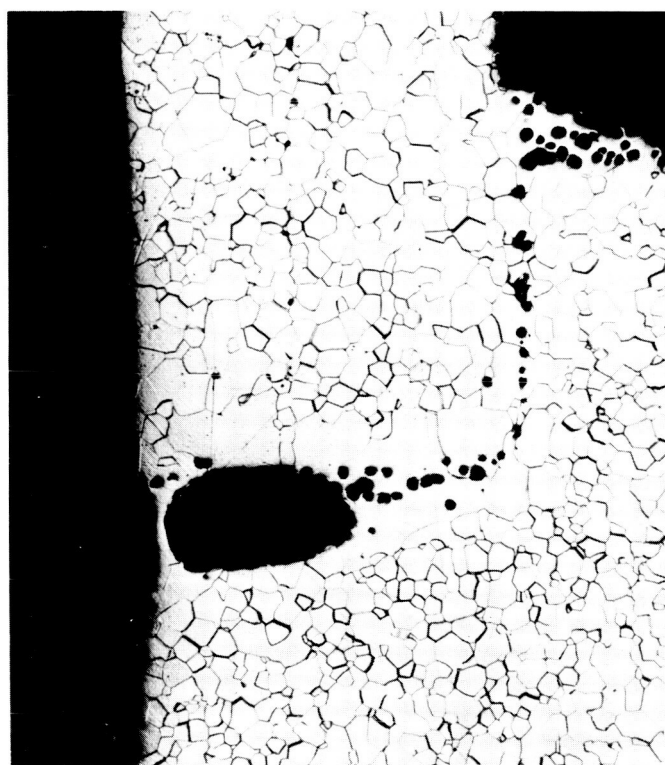
a. Capsule 3 - 500 hours

b. Capsule 4 - 1000 hours

Capsules 3 and 4, tested at  $1800^\circ\text{C}$  for 500 and 1000 hours, respectively, were examined. These capsules were fabricated by brazing the end caps to the tube section with a Mo-50 wt % Re alloy. There was no evidence of any  $\text{UO}_2$ /W-25 wt % Re interactions or evidence of sigma phase. The braze areas of the capsules were examined and porosity was observed in these regions. The microstructures are shown in Figure 10. There was no

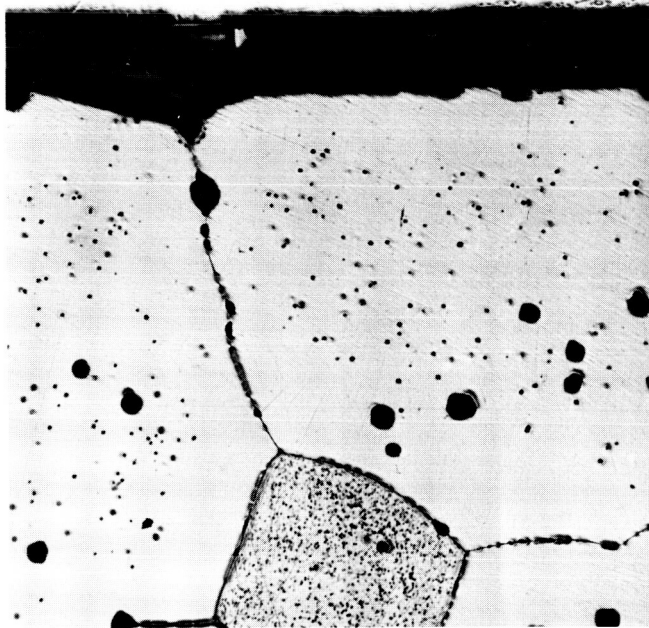
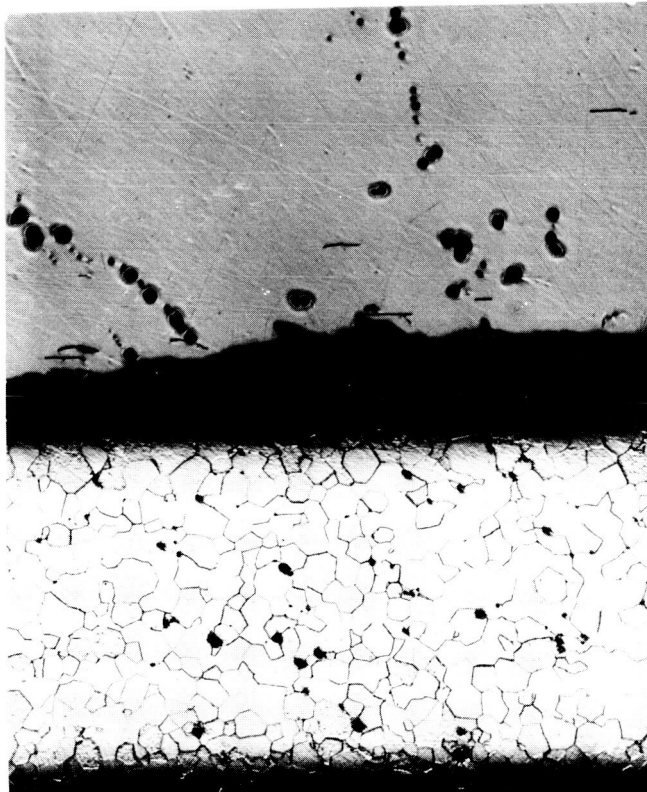
FIGURE 13. TYPICAL INTERFACES OF LONGITUDINAL SECTIONS OF CAPSULES TESTED AT 2200°C

a. Capsule 11 - 500 hours

Capsules 11 and 12 were tested at 2200°C for 500 and 1000 hours, respectively. In the course of testing both capsules, the Ta chamber ruptured during the first 500 hours of testing which resulted in a high loss of  $\text{UO}_2$ . Metallographic observations revealed no gross interaction between the  $\text{UO}_2$  and the W-25 wt % Re; typical interfaces of capsules 11 and 12 are shown in Figures 13 a and b, respectively. However, at higher magnifications of 1000X, a thin layer, approximately  $1\ \mu$  thick of a metallic appearing phase was observed along the inner edge of the nonvented end cap of capsule 11 (Figure 14). This thin layer was attacked by a conventional  $\text{UO}_2$  etchant which indicated U. A superficial interaction was also detected at the interface of the  $\text{UO}_2$  and the vented W-25 wt % Re end cap of capsule 12. A small amount of phase of the appearance of  $\text{UO}_2$  penetrated grain boundaries immediately along the edge of the inside of the cladding as shown in Figure 15. No evidence of this type of superficial interaction was observed in any other capsule.

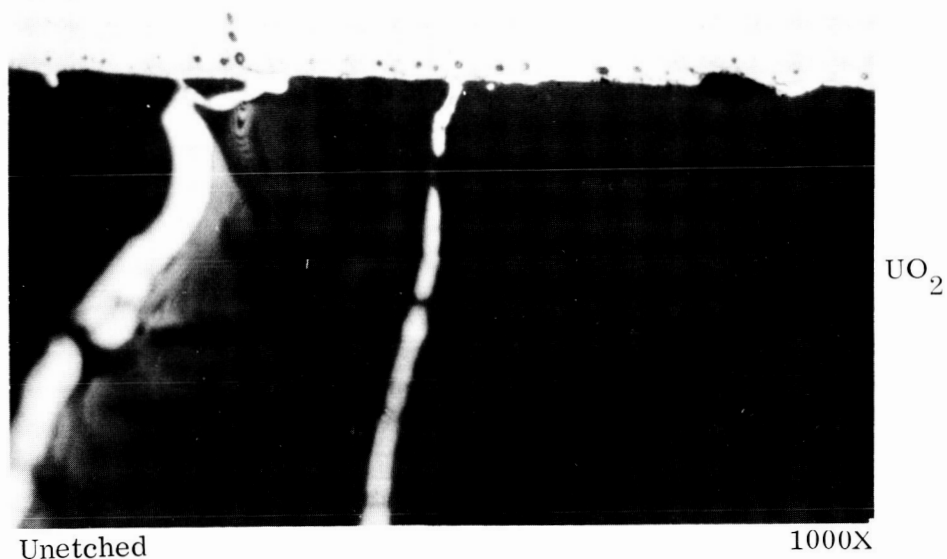
FIGURE 15. NONMETALLIC PHASE (Dark Phase) PENETRATING W-25% Re END CAP GRAIN BOUNDARIES ALONG INTERFACE WITH UO<sub>2</sub>. WHITE PHASE IN UO<sub>2</sub> APPEARS TO BE METALLIC. CAPSULE 12. (2200°C - 1000 hours)

The nonmetallic inclusions seen in the cap of capsule No. 12 (Figure 15) contained uranium but were too small for quantitative analysis. The uranium content of the particles, their fluorescence in the electron beam and their reddish color under polarized light indicated the particles were  $\text{UO}_2$ .

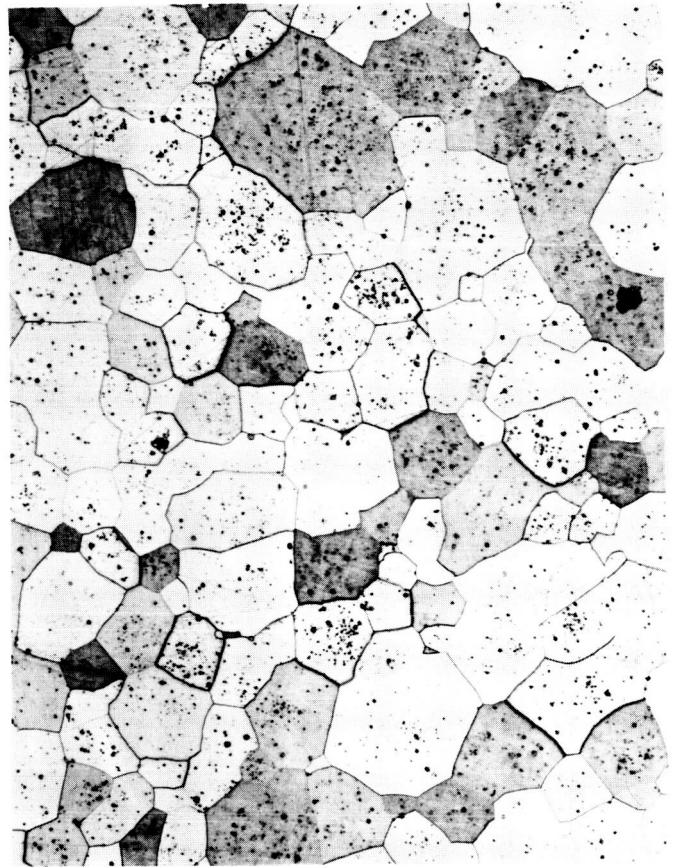
FIGURE 16. GRAIN STRUCTURES OF URANIUM DIOXIDE  
OF CAPSULE NO. 7 ( $1800^{\circ}\text{C}$  - 5000 hours)

Metallographic analysis of capsule 7, tested for 5000 hours at  $1800^{\circ}\text{C}$  was performed. No evidence of interaction between the  $\text{UO}_2$  and W-25 wt % Re was detected. There was an indication that the W-25 wt % Re and  $\text{UO}_2$  tend to collect in the vent after prolonged testing times at  $1800^{\circ}\text{C}$ . A macrograph of the longitudinal section of the capsule is shown in Figure 11a, and the microstructure of the  $\text{UO}_2$  cladding interface is illustrated in Figure 11b. Porosity was observed in the tube section of the capsule (Figure 11b); however, the end caps contained very little porosity. In one end cap of the capsule, very large grains were observed. The grain size of the clad tube

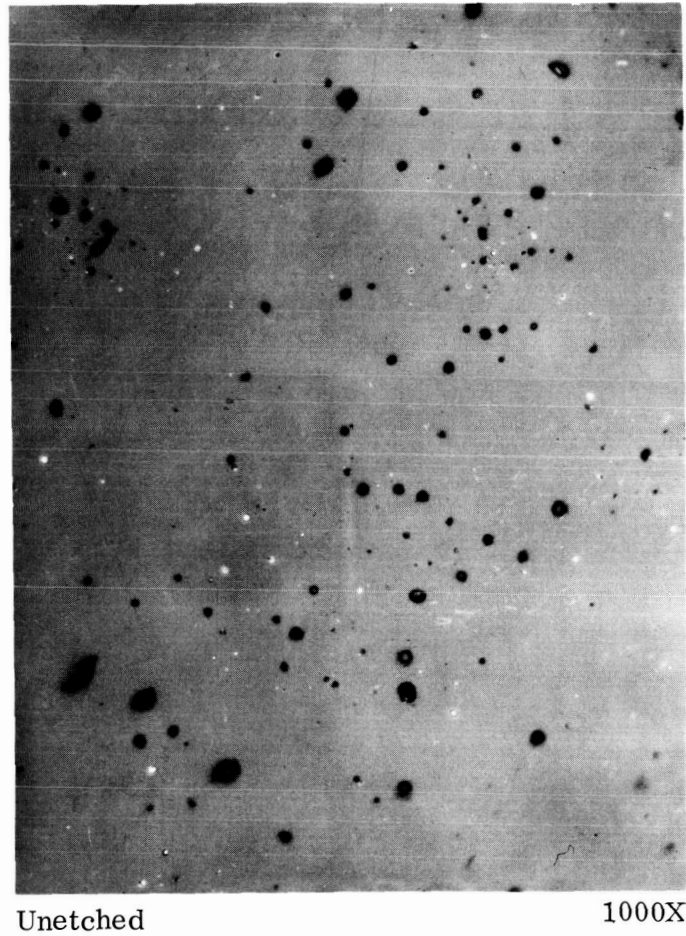
FIGURE 17. METALLIC PHASE TYPICAL OF THAT FOUND IN THE  $\text{UO}_2$  OF CAPSULES 3 AND 4, TESTED AT  $1800^\circ\text{C}$  FOR , 500 and 1000 HOURS, RESPECTIVELY

The  $\text{UO}_2$  in all capsules contained a metallic appearing phase of varying morphology. In some capsules, e.g., capsules 3 and 4, 500 and 1000 hours at 1800°C respectively, the metallic phase was randomly distributed in very fine particles (Figure 17). In the  $\text{UO}_2$  of other capsules, the metallic phase was precipitated in the grain boundaries, pores and cracks as shown in Figure 18. The amount of the metallic phase appeared to increase with an increase in test temperature. (Compare Figures 17 and 18, 1800°C versus 2200°C, respectively.)

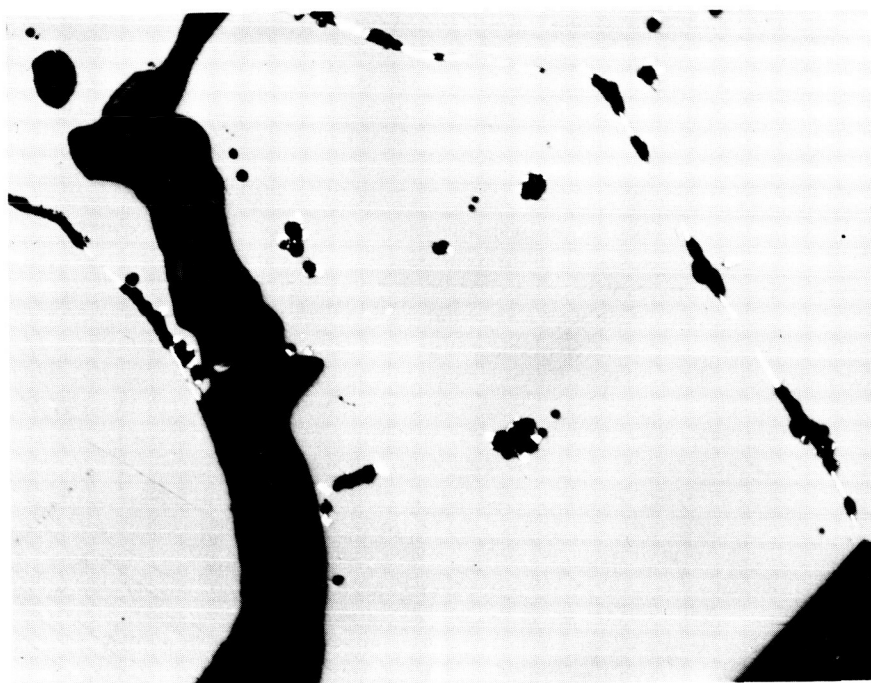
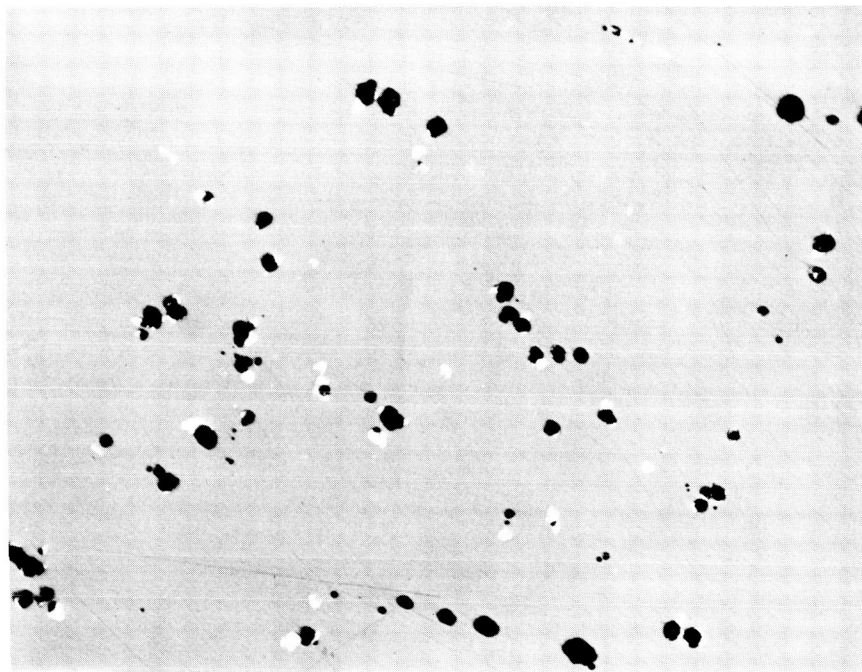
a. Metallic Phase in  $\text{UO}_2$  Grain Boundary of Capsule 11 ( $2200^\circ\text{C}$  - 500 hours)

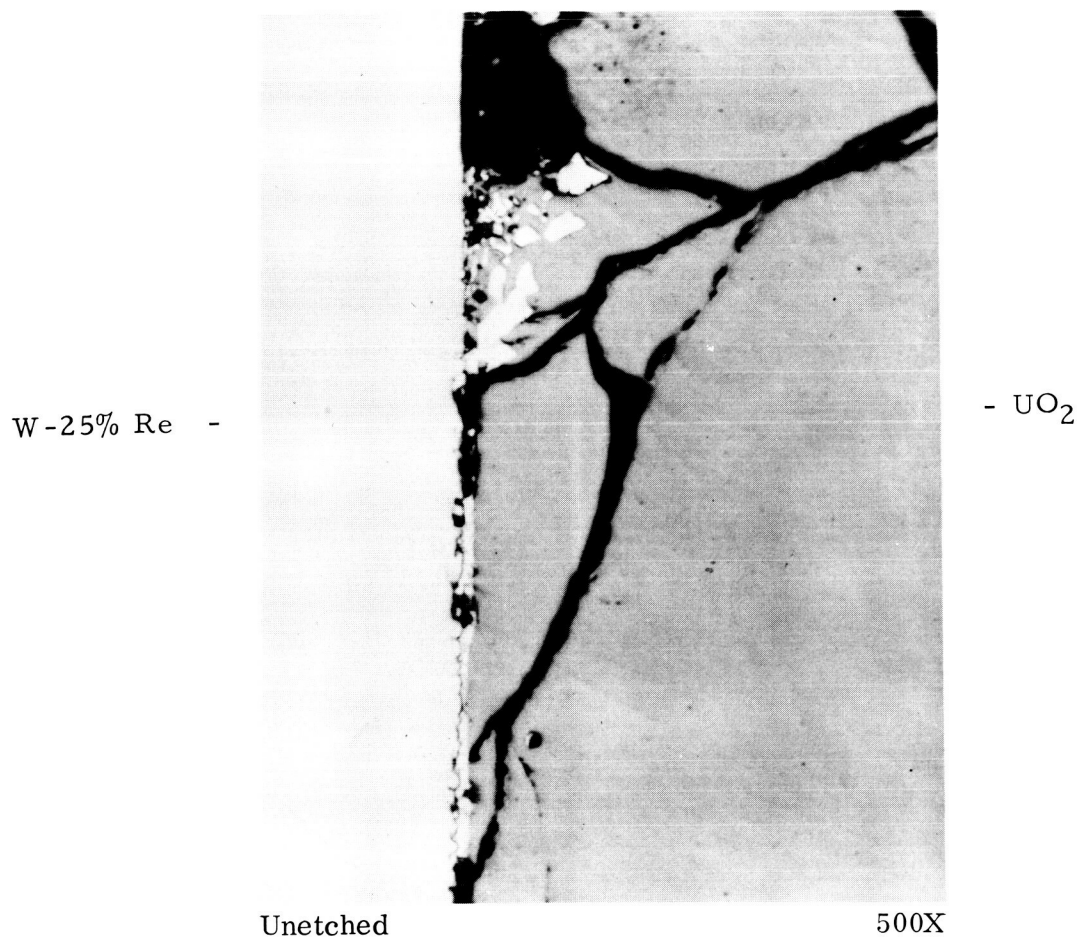
FIGURE 19. METALLIC INCLUSIONS IN  $\text{UO}_2$  IN CAPSULE NO. 11  
( $2200^\circ\text{C}$  - 500 hours)

Another type of metallic inclusion not previously observed was found in two areas along the  $\text{UO}_2$  end cap interface of capsule No. 11 when it was repolished for microprobe analysis, Figure 19. The microprobe showed these inclusions contained  $\sim 72\%$  uranium,  $\sim 13\%$  aluminum,  $\sim 10\%$  rhenium, and  $\sim 5\%$  tungsten. The aluminum existed as an impurity in  $\text{UO}_2$ . No aluminum was found in the  $\text{UO}_2$  or clad immediately adjacent to the inclusions.

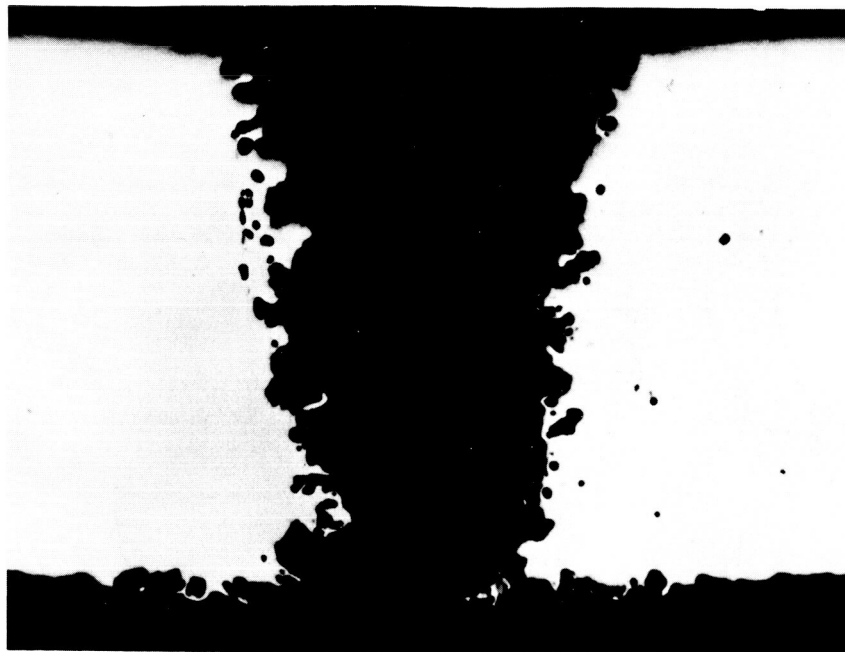
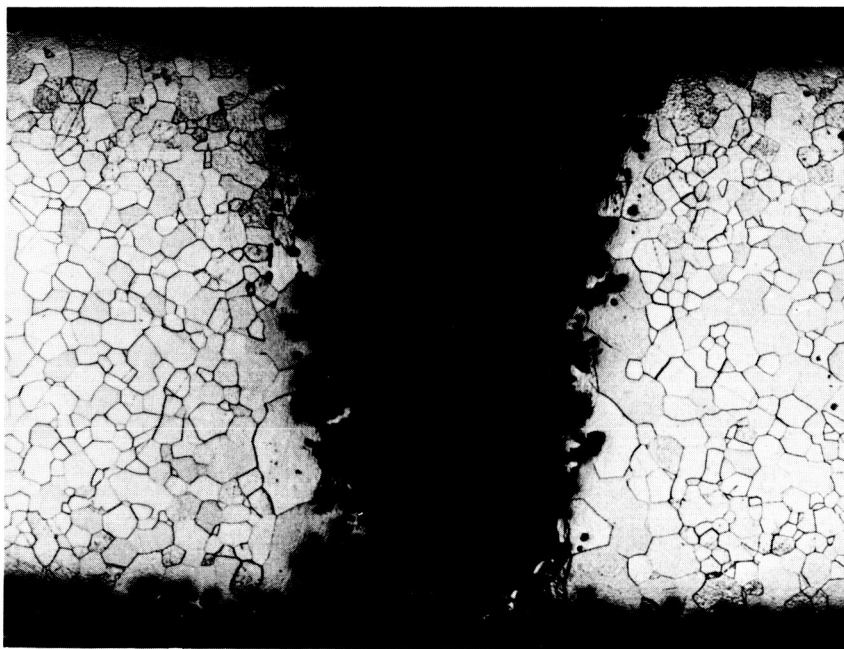
FIGURE 20. VENT OF CAPSULE NO. 7.  $1800^{\circ}\text{C}$  - 5000 HOURS.  
THE URANIUM DIOXIDE PELLETT (not shown) IS  
ADJACENT TO THE MINIMUM VENT DIAMETER

Of considerable interest in both capsules No. 7 and 10 were the metallic deposits found in the vent hole of each (Figures 20 and 21 respectively). A thin bridge of  $\text{UO}_2$  or  $\text{UO}_2$  and tungsten/rhenium may have existed across the narrow end of the vent hole of capsule No. 7. The reason for believing a bridge existed is that a number of loose particles of  $\text{UO}_2$  containing metallic inclusions of tungsten/rhenium were formed in the mounting epoxy directly opposite and below the vent hole. The  $\text{UO}_2$  may have been broken away from the bottom of the vent hole during metallographic mounting or sectioning procedures. No evidence of metallic inclusions of tungsten/rhenium were found anywhere else in the  $\text{UO}_2$  inside the capsule.

The vent deposits of capsules 7 and 10 contained nonmetallic inclusions which were identified as  $\text{UO}_2$ . A spectral scan of the nonmetallic phase also indicated the presence of a few tenths of a percent tungsten, but no rhenium.

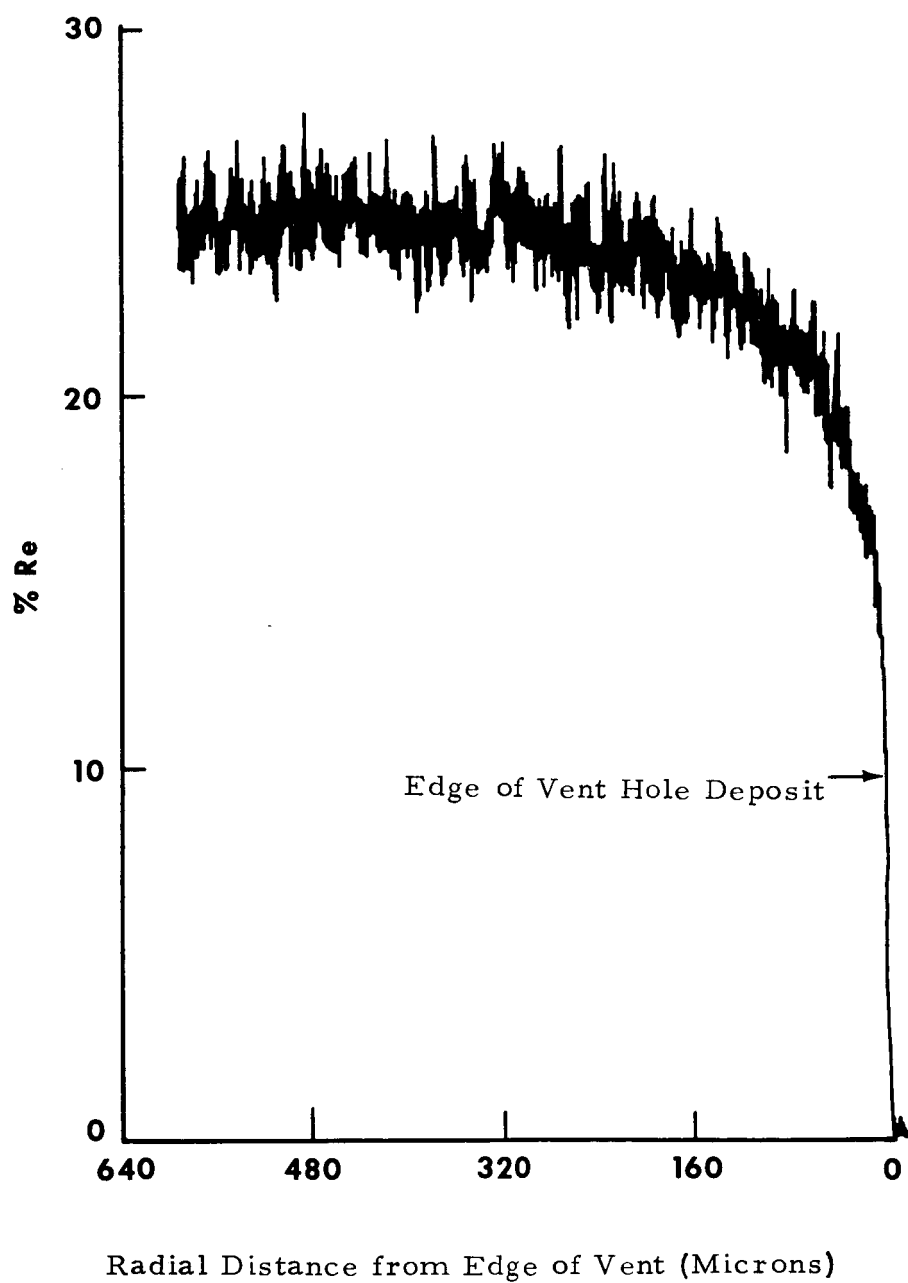
FIGURE 22. ELECTRON MICROPROBE SCAN OF RHENIUM IN TUNGSTEN/RHENIUM CAP OF CAPSULE NO. 10. (2000°C - 3000 hours)

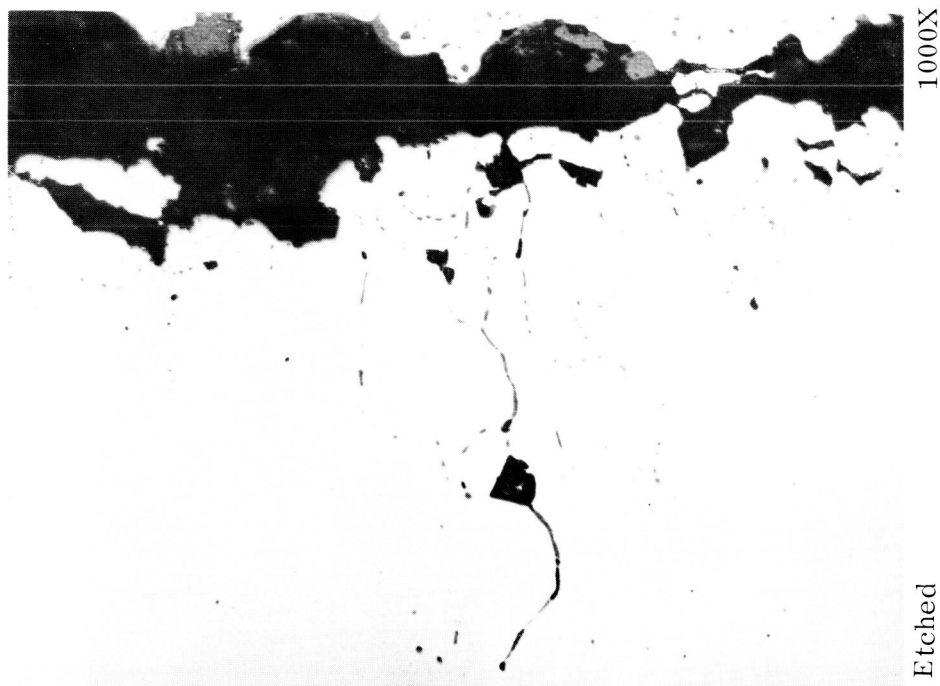
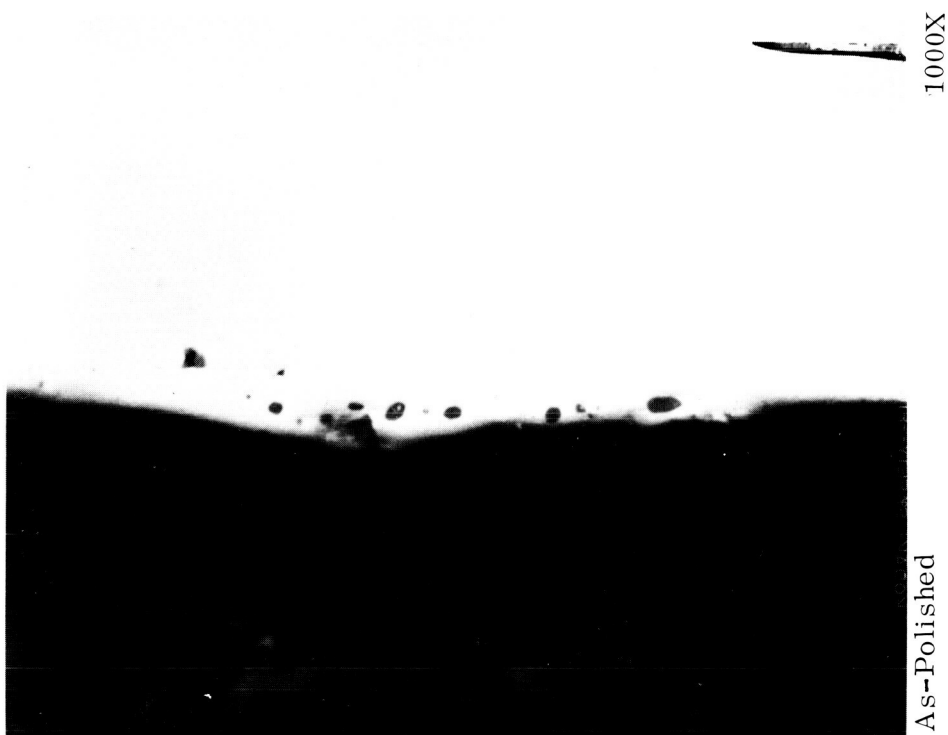
a.  $\text{UO}_2$  (grey inclusions) found in clad wall

b.  $\text{UO}_2$  (appears grey) found in clad above one weld gap

FIGURE 24. SAMPLE E CYCLED 2200-1600°C. TRACES OF INTERACTION

No gross interaction between the  $\text{UO}_2$  and the W-Re was observed in any of the capsules; however, traces of interaction were found in capsule E. Two isolated areas showed nonmetallic inclusions in the container (identified as  $\text{UO}_2$  by microprobe analysis). One area near the edge of the container wall had inclusions up to 5 microns (Figure 24a). The other area near one weld gap had somewhat larger inclusions (Figure 24b). It is hypothesized that the  $\text{UO}_2$  in the container wall was the product of an excess oxygen reaction. Small pits appeared at four or five locations along the container cap after etching. It was thought that these pits may have been areas where a second metallic phase had formed. Upon repolishing capsule E in preparation for microprobe analysis, these areas disappeared and could not be identified with the microprobe.

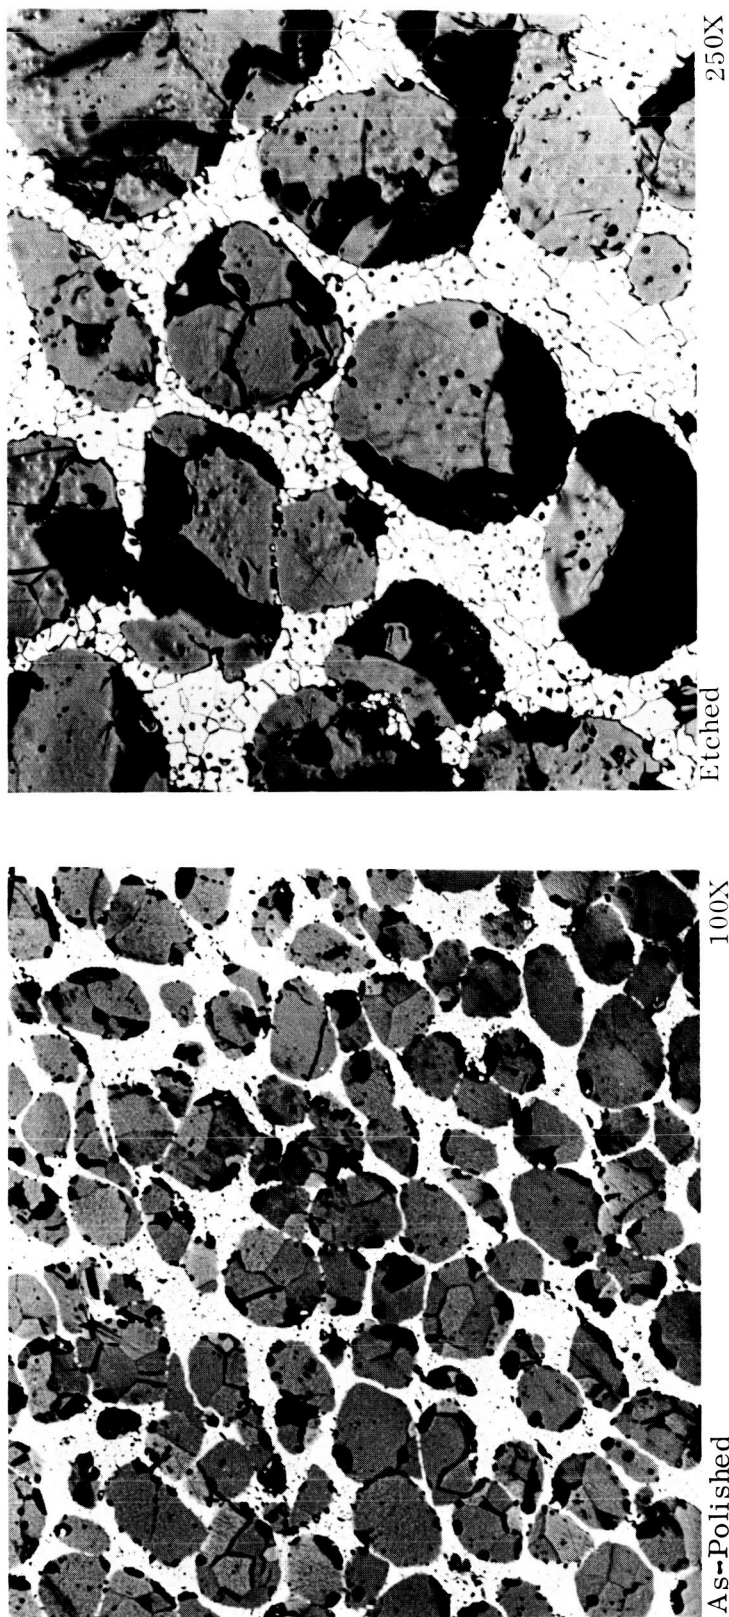
FIGURE 25. TYPICAL W-60 vol %  $UO_2$  CERMET FUEL. THE ROUGHLY SPHERICAL  $UO_2$  PARTICLES (appears grey) ARE IMBEDDED IN A TUNGSTEN MATRIX (appears white). THE BLACK AREA IN SOME  $UO_2$  PARTICLES IS BELIEVED TO BE PULLOUT

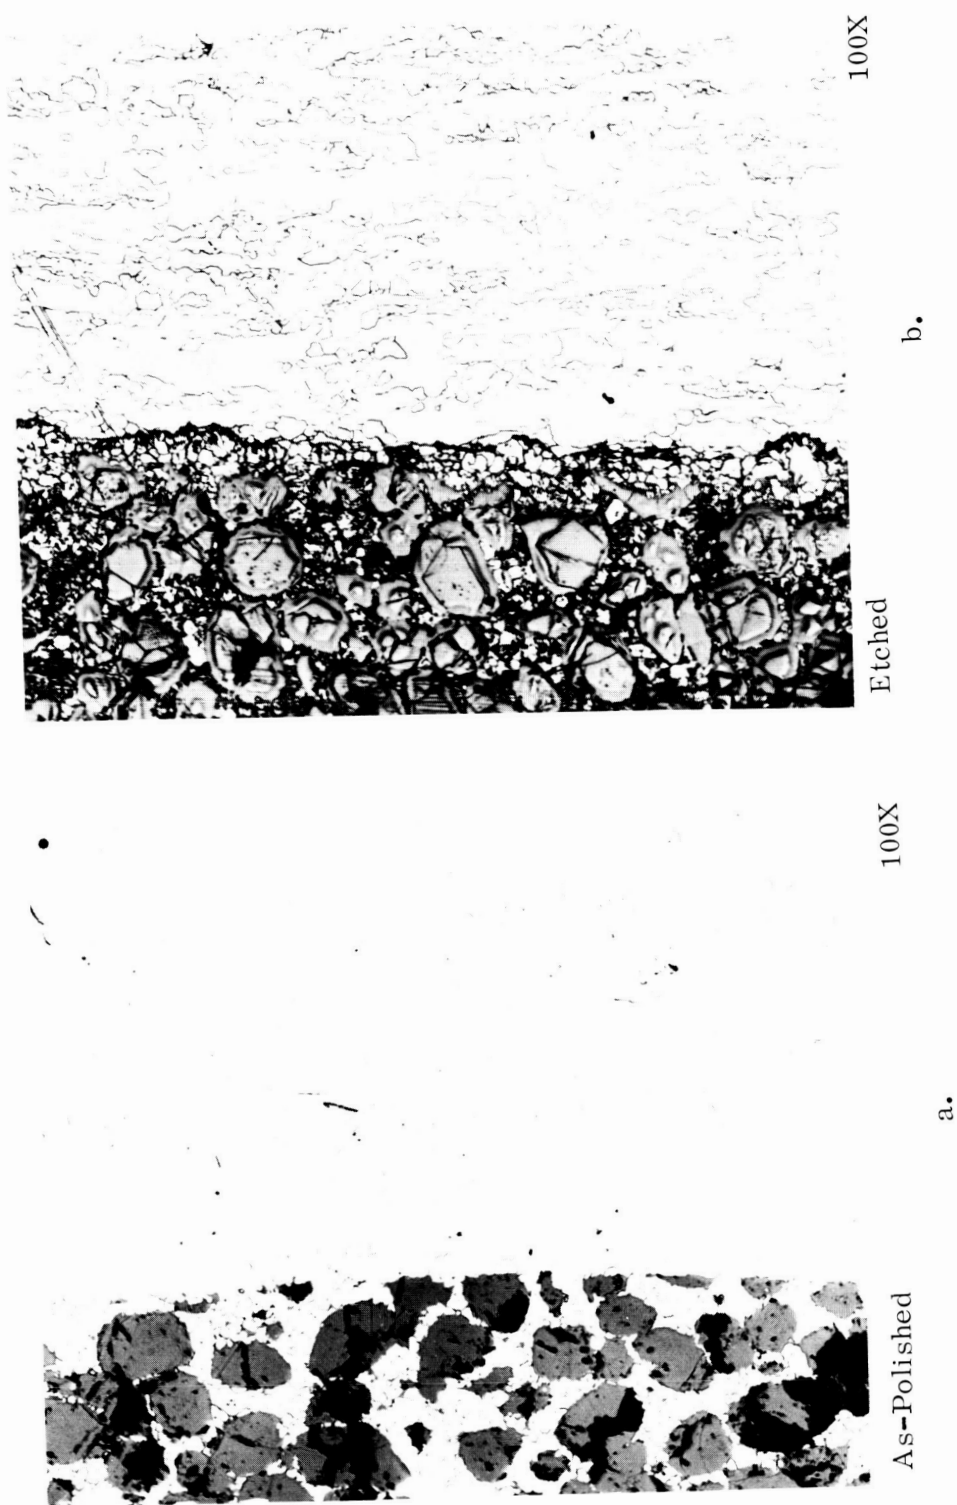
FIGURE 26. TYPICAL W-60 vol %  $UO_2$  INTERFACIAL AREA BETWEEN AS-BONDED CERMET CORE (left) AND W/Re CLAD (right)

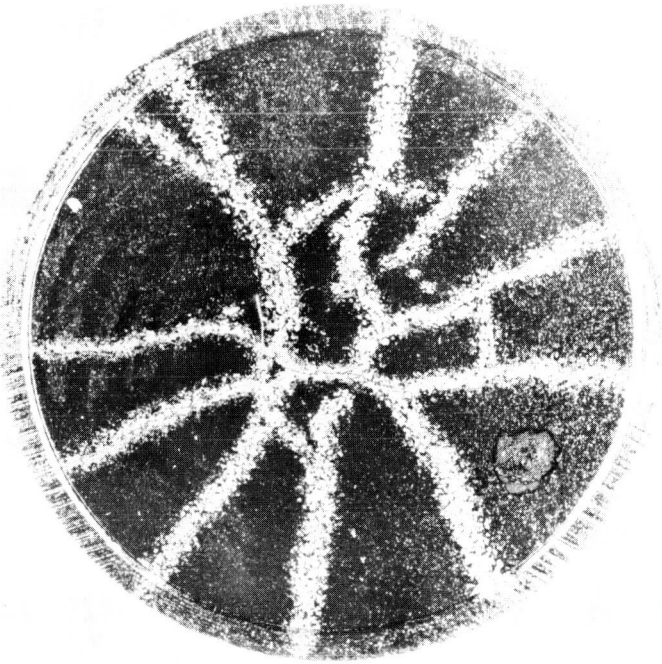
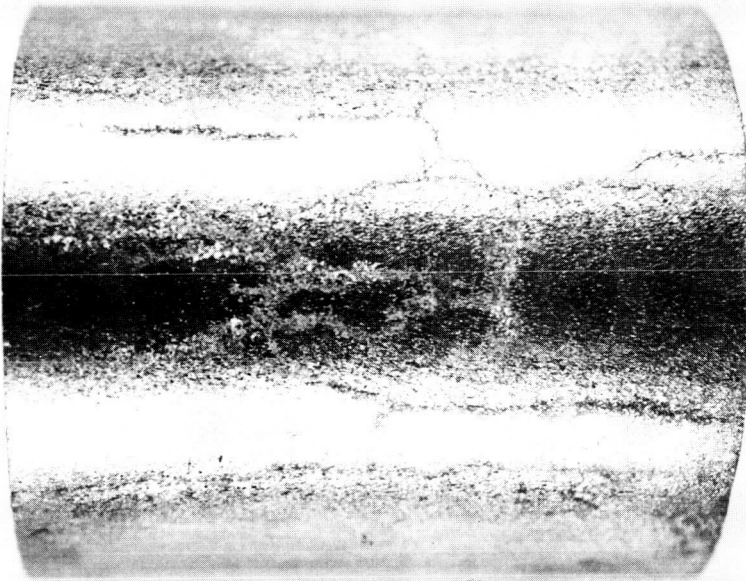
b. View of radial cracks in top  
cap of capsule

a. Side view showing longitudinal  
and circumferential cracks
